SAFETY MARKING AT FEDERAL ROAD GERMANY

PROJECT OBJECTIVE

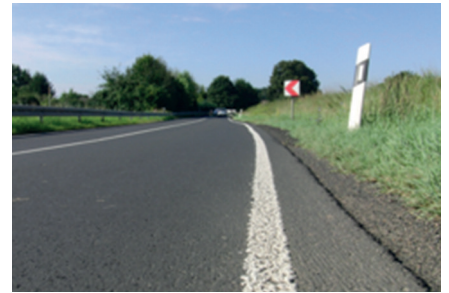
After: safety marking based on DEGAROUTE®

authority, Hessen Mobil, improved the safety on this road by applying a structured marking based on DEGAROUTE® cold plastic.

- Improved safety: three years since application, the road is no accident hot spot any more
- The structured edge line is not only highly visible (even under wet night conditions), it also prevents drivers from leaving the road by a warning rumble and sound
- Improved safety was achieved at relatively low cost, i.e. without construction work
- Besides the structured markings, the speed limit was reduced from 70 km/h to 50 km/h (43 mph to 31 mph) and vertical signs were exchanged to ones with higher reflectivity
