# AREA MARKING ON CONCRETE GERMANY

## PROJECT OBJECTIVE

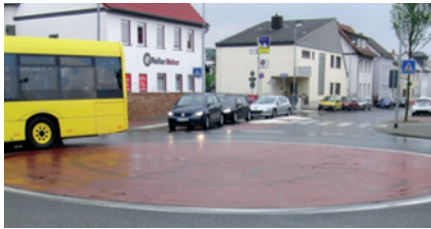
After application in 2010

The red roundabout on a high traffic crossing area in Bad Vilbel had caused the city much undue stress. Large buses and trucks could not circumvent the radius of the roundabout without driving on the edge of the area marking. Therefore, it was important for the city to find

a road marking material that could withstand the traffic exposure on the concrete surface. In 2010, after various trials with other materials that eroded within a short period of time, the city of Bad Vilbel opted for cold plastic MMA, which is known for its long durability and adhesion to concrete substrates. Thanks to the

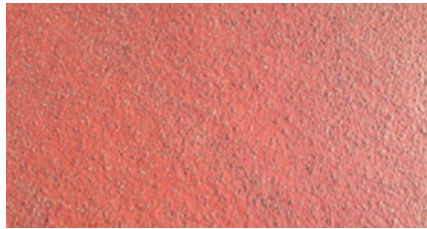
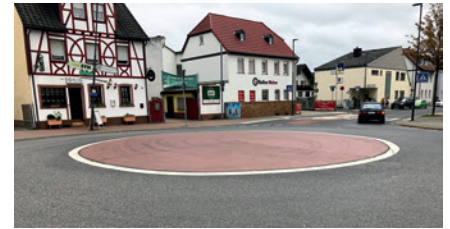
2019 after 9 years in service

outstanding durability of the cold plastic material, this led to increased safety and an elimination of constant maintenance repairs. Even after nine years in service, the red area marking based on DEGAROUTE® is still as visible as the first day it was installed and fulfills all requirements regarding grip.

- High durability of cold plastic, where other markings failed
- High traffic density: DTV 16,600 cars/24h with extreme sheer forces
- Grip after 9 years still well above 45 SRT
- Excellent color stability
