AREA MARKING ON CONCRETE GERMANY

PROJECT OBJECTIVE

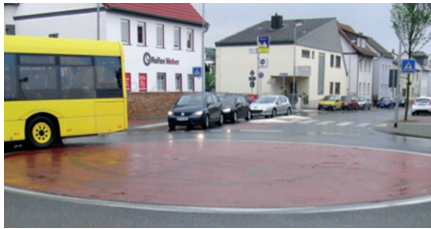
After application in 2010

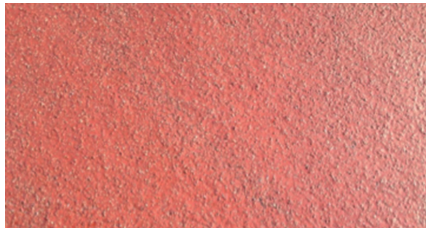
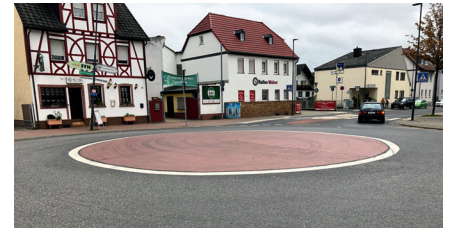
2019 after 9 years in service

to concrete substrates. The result was increased safety. After three years, the red area marking based on DEGAROUTE® is still very well visible and fulfills all requirements regarding grip. Even after 9 years in service, the red roundabout in Bad Vilbel still looks like on day one.

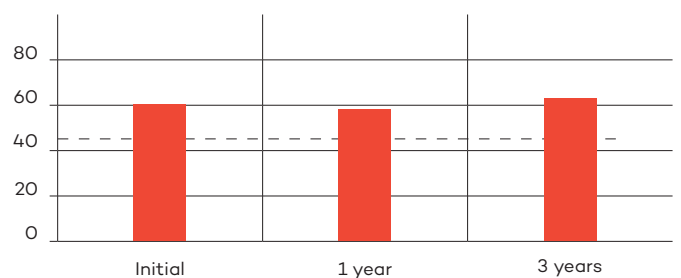
SKID RESISTANCE (SRT)

- High durability of cold plastic, where other markings failed
- High traffic density: DTV 16,600 cars/24h with extreme sheer forces
- Grip after 3 years still well above 45 SRT
- Excellent color stability
