ROUNDABOUT AUSTRIA

PROJECT OBJECTIVE

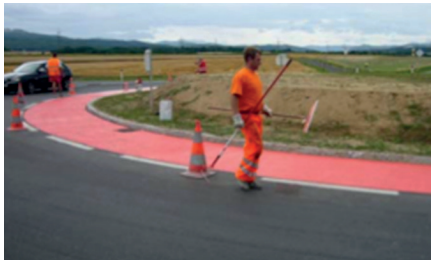
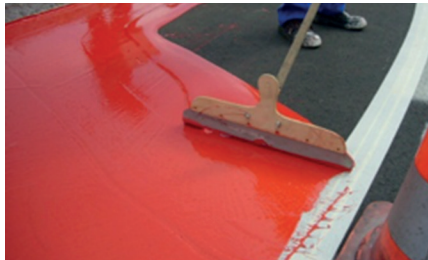
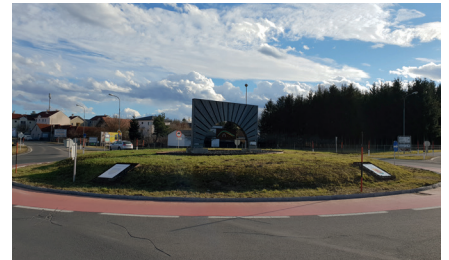
Application in 2019 after 12 years in service

After more than 12 years, the application provides the minimum SRT of 45 and is still in service.

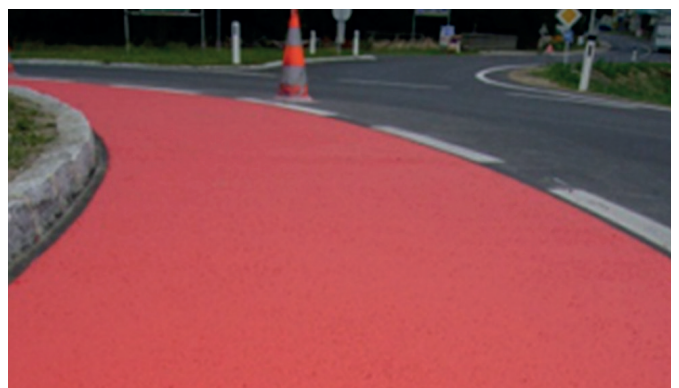
Certificate September, 2015 – Research Center for Surface Engineering:

“For all the measurement points of the road markings the minimum skid resistance values of 45 PTV (SRT) units were exceeded, thus satisfying the requirements of the standards”
