## DEGAROUTE® Project Profile – *Crosswalk*

Location: Intersections of Colorado Blvd and East Colfax Ave, East 14th Ave, and East Montview Blvd, Denver, CO

Application Date: July, 2011

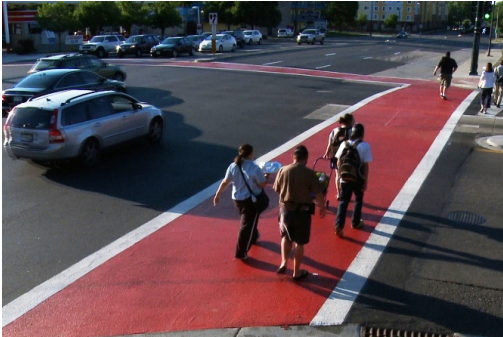
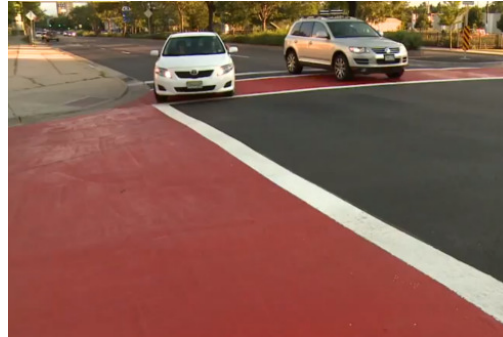
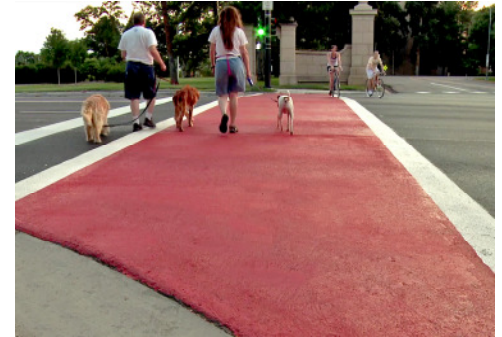
Red area markings were used to define crosswalks at three busy intersections in downtown Denver, Colorado. The largest of the intersections was 16 lanes of traffic. Area markings were used for both the red crosswalks and the white accent stripes. The material covered a 4,750 ft<sup>2</sup> area and reflective beads were added to the surface of the accent stripe.

DEGAROUTE® System: One layer system

Application Method: Hand rollers

Total thickness: Approx. 100 mils

Aggregate used: #1 silica sand
