## DEGAROUTE®

### Profile Markings help saving lives

Country:	Germany
Location:	German–Polish border (in Forst City)
Applicator:	Limburger Lackfabrik GmbH. (Test application)
Application Date:	January, 2012

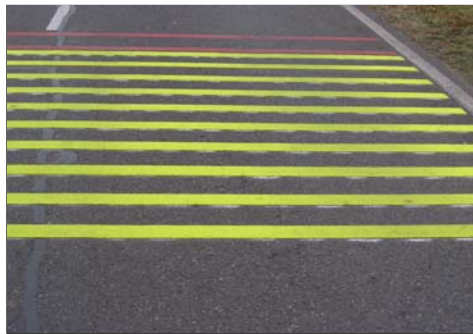
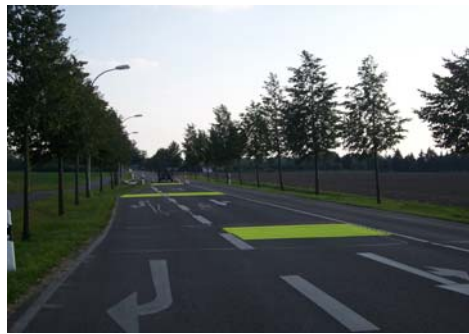
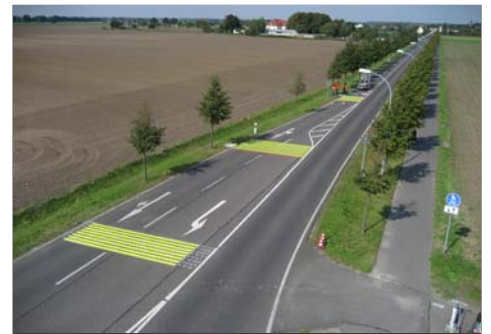
The 1 cm thick, shiny yellow marking strips were installed perpendicular to the road, getting the drivers' attention through colour contrast, vibrations and noise. In 2010 there were 8 accidents, mostly caused by speeding and some of them involving casualties. Since the application of the rumble strips, not a single accident has occurred.
